# Intrathecal Migration of a Broken Posterior Spinal Rod

## A Case Report

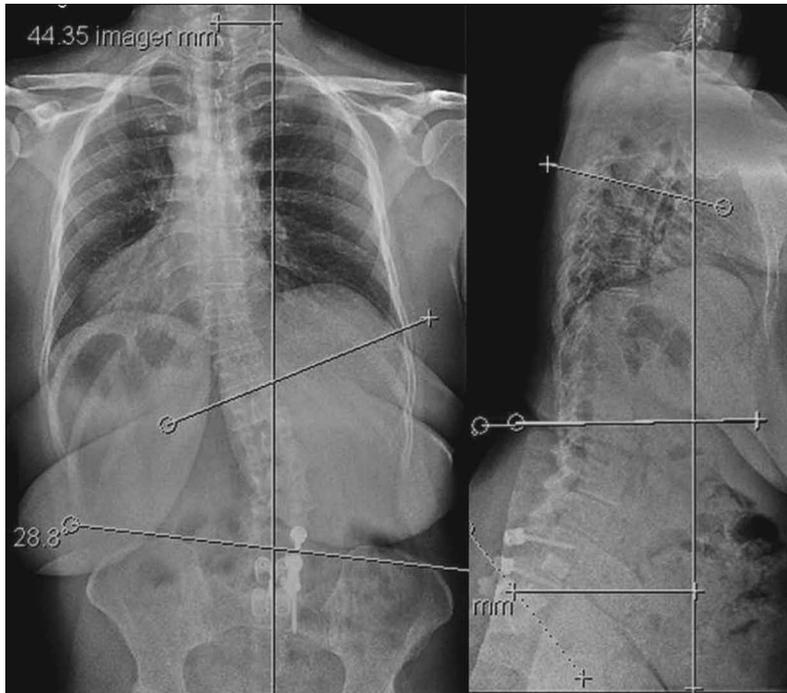
**Figure 1** AP and lateral preoperative standing scoliosis radiographs demonstrating L5 to S1 instrumentation with broken hardware and showing a 28° coronal curve and a sagittal vertical axis that is 10 mm positive.

Radiographs demonstrated coronal and sagittal imbalance (C7 plumb: 4.4 cm left to S1 in coronal plane and +17.1 cm in sagittal plane) and lumbar scoliosis of 28° at L1-L5 above the previous instrumented fusion. The right side pedicle screws at L5, L6, and S1 were in good position without halo or breakage. The broken proximal rod at L5-L6 was seen in the midline of the L6-S1 disc. Minimal evidence of posterior bony fusion mass was observed, and the PLIF cages were in a good position (Figs. 1 and 2).

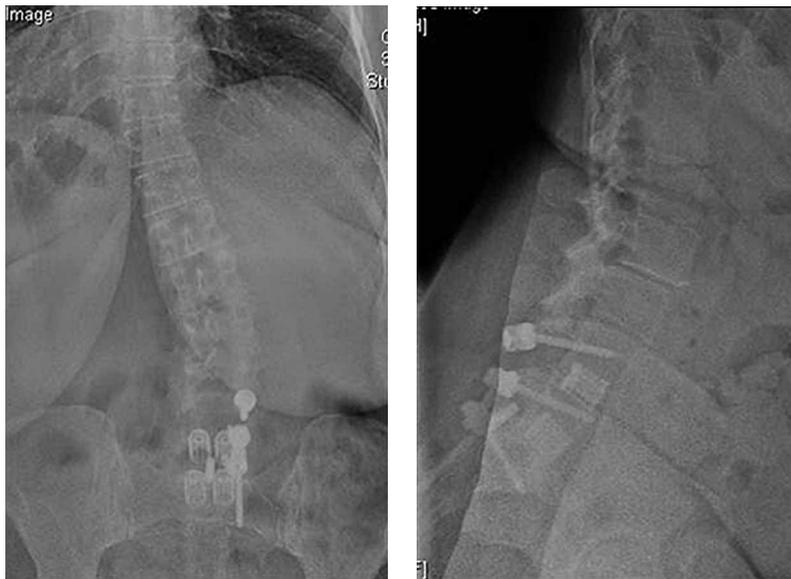
**Figure 2** Preoperative standing lumbar spine anteroposterior and lateral radiographs.

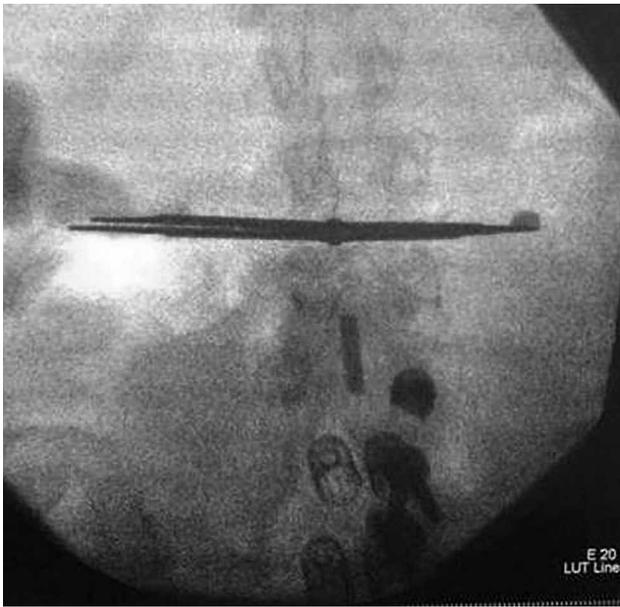
**Figure 3** Radiograph of the lumbar spine after prone positioning in the operating room showed proximal migration of the broken rod.

Intraoperative imaging after prone positioning the patient confirmed the presence of a migratory broken rod at the level of the L4 vertebral body (Fig. 3). A 6 mm dural defect was identified in the area of L6. A durotomy was performed to remove the migratory intradural rod. The 23 x 5.5 mm rod fragment with a small amount of intrathecal hematoma was identified and removed along with the rest of the retained hardware (Figs. 4 and 5). The sac was repaired with a 6-0 Prolene® suture (Ethicon Inc., Bridgewater, NJ). DuraGen® graft matrix (Integra LifeSciences Corp.,

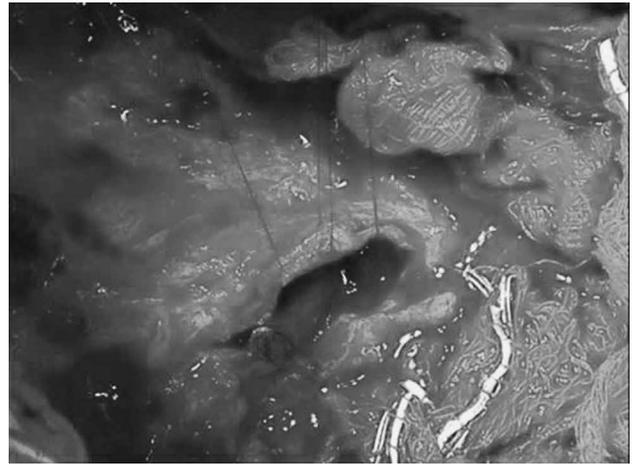
**Figure 4** Durotomy held open with sutures while removing intrathecal rod.

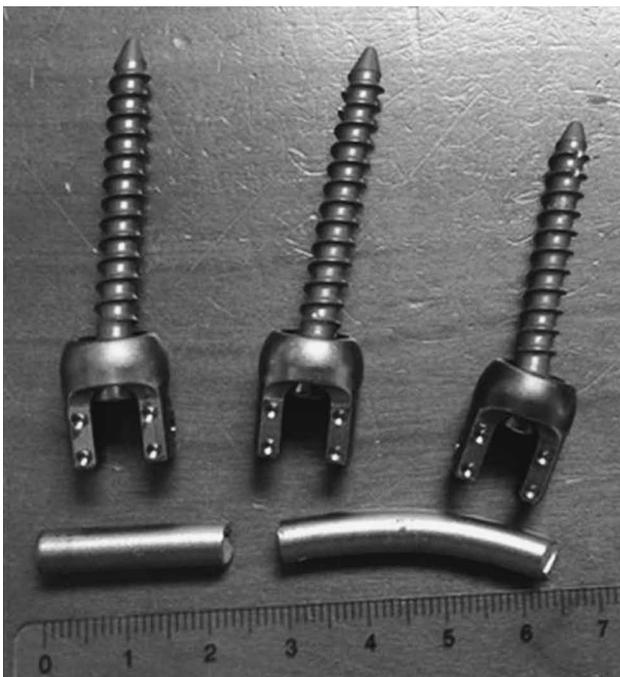
**Figure 5** Broken rod after removal.

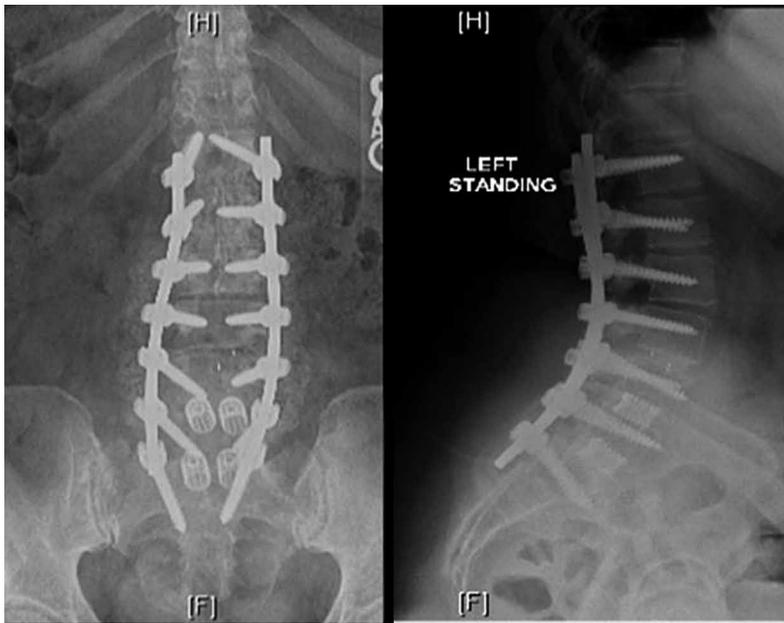
**Figure 6** Six months postoperative anteroposterior and lateral lumbar radiographs.

extremity. Her neurological exam had improved, and she had 5/5 strength in both her lower extremities. Lumbar spine x-rays demonstrated adequate hardware position and visible fusion mass (Fig. 6).
